LOWER ST CROIX RIVER

ORDINARY HIGH WATER MARK EVALUATION

FIELD SITE LOCATIONS

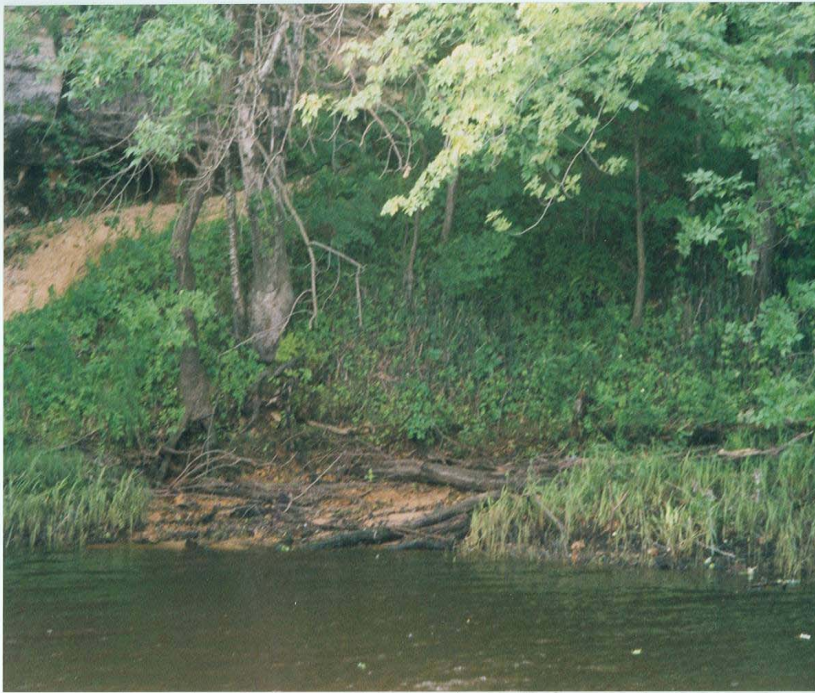
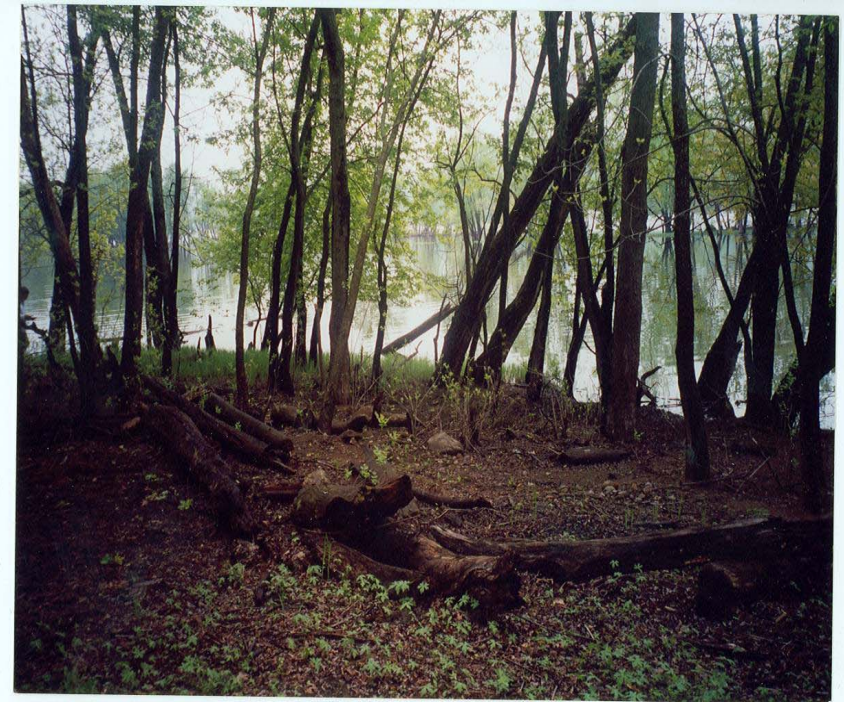
Twin Springs Boat Landing

Transect 1 pictured in 2 photos on the right

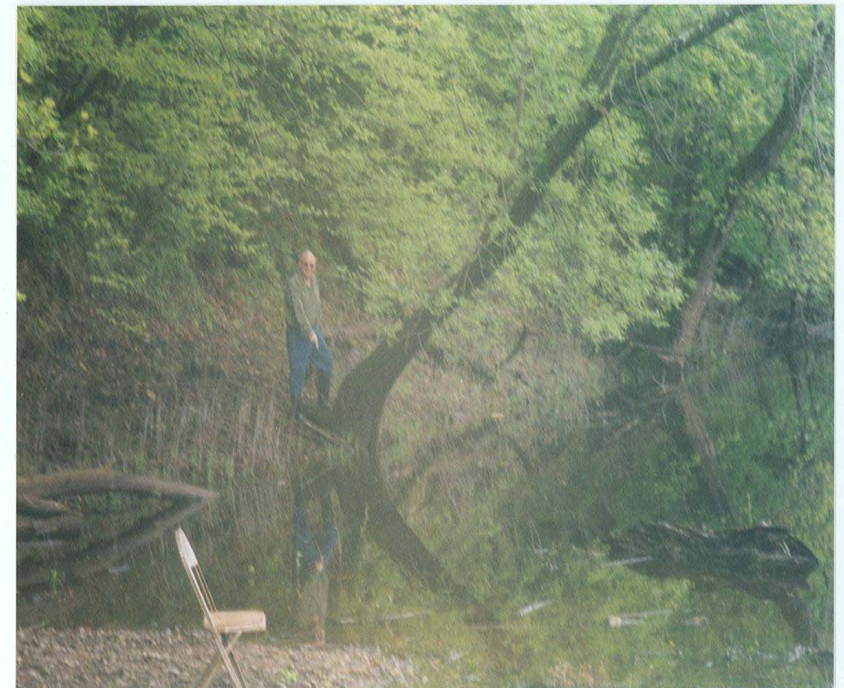
Transect 2 pictured above---note exposed roots and erosion line

That is Bob Rolle pointing to a root of an American elm

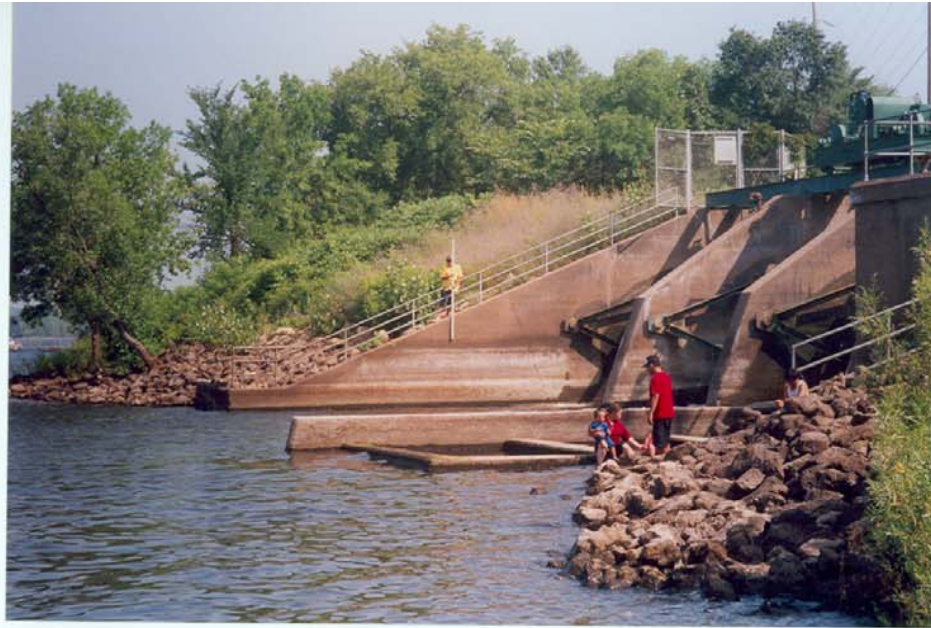
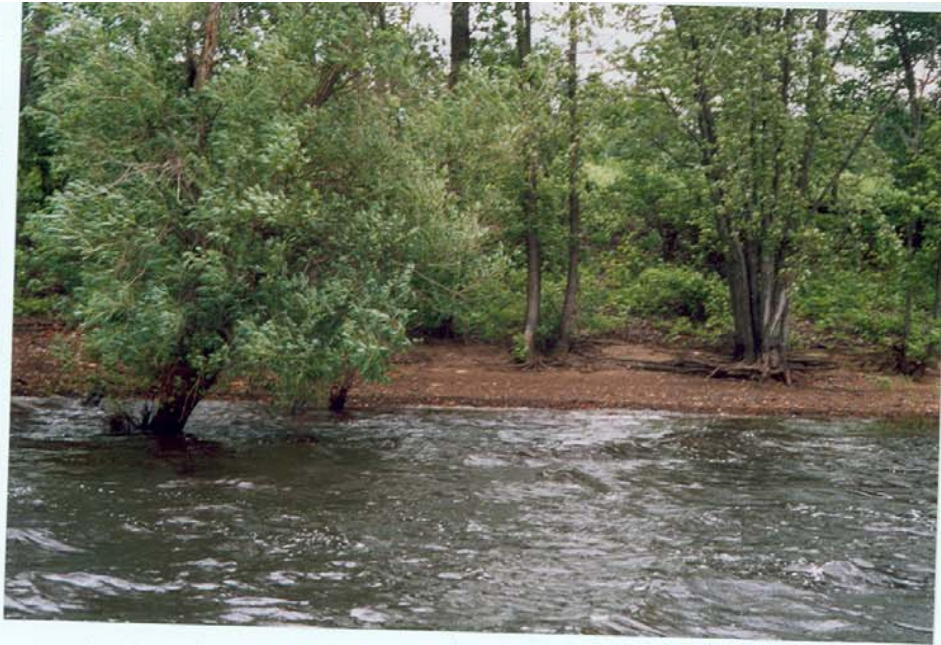
Lake Mallalieu Dam/Union Pacific Railroad Property.

Notice water stains on the riprap and on the walls of the dam in left photo

Notice large area in which all trees have exposed roots in photo on the right

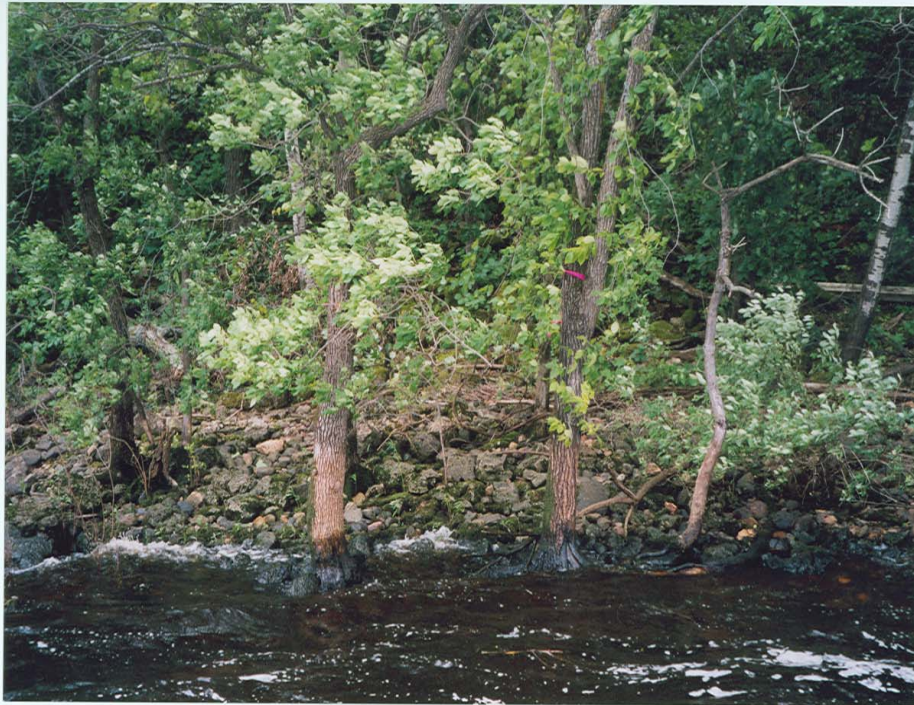
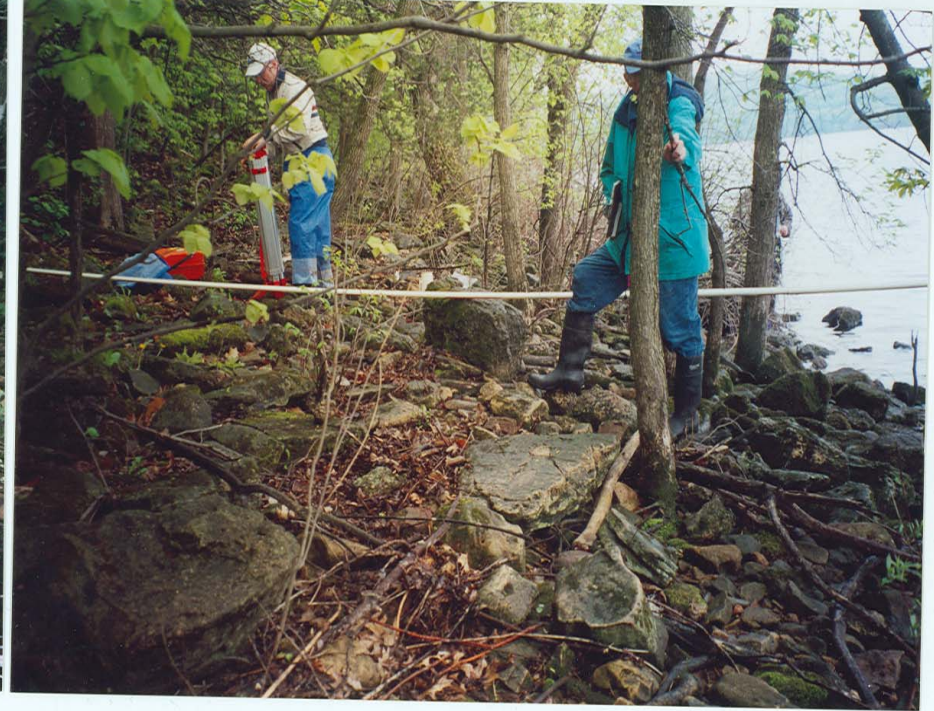
Bob Rolle property—Transect 1 above right, Transect 2 above left

Upper left—notice water stain on trees and light water stain on the rocks are at close to the same height

Upper right—notice 3 different color of water stains on rock (dark at water, light, then dark again more inland)

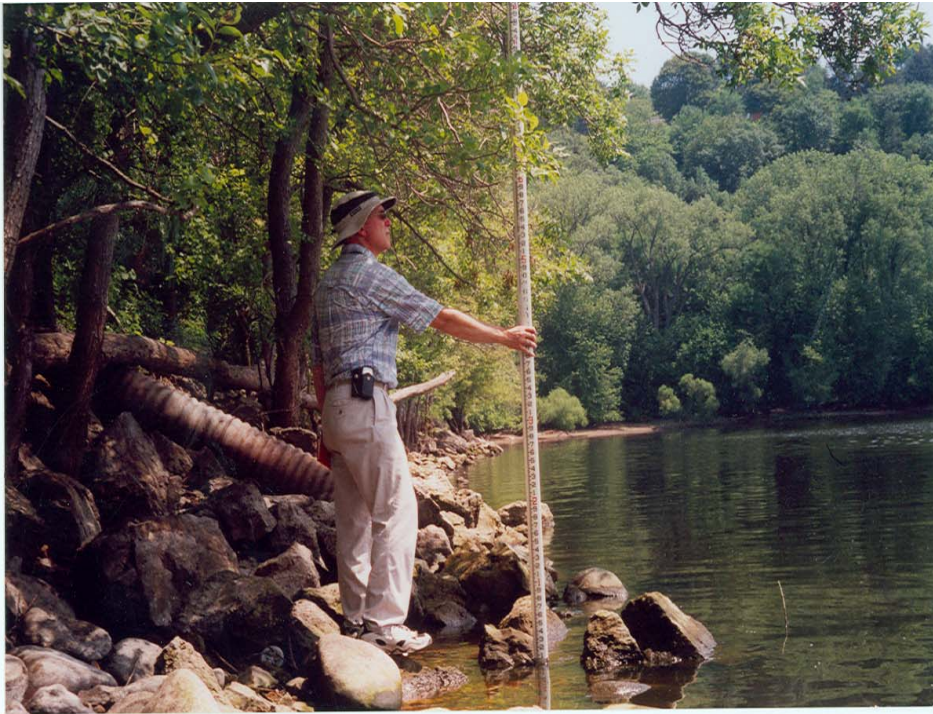
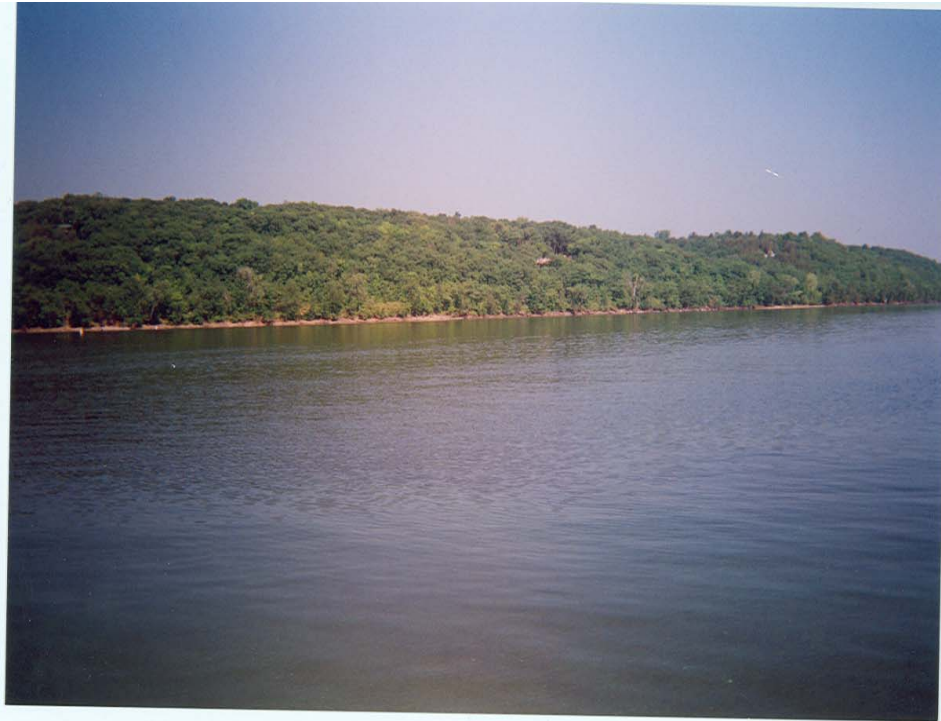
As we were working, we noticed a “browse line” about 5 feet high where the vegetation at the water’s edge did not have limb growth from the main trunk. This “browse line” is more easily seen from a distance as shown in upper right photo.

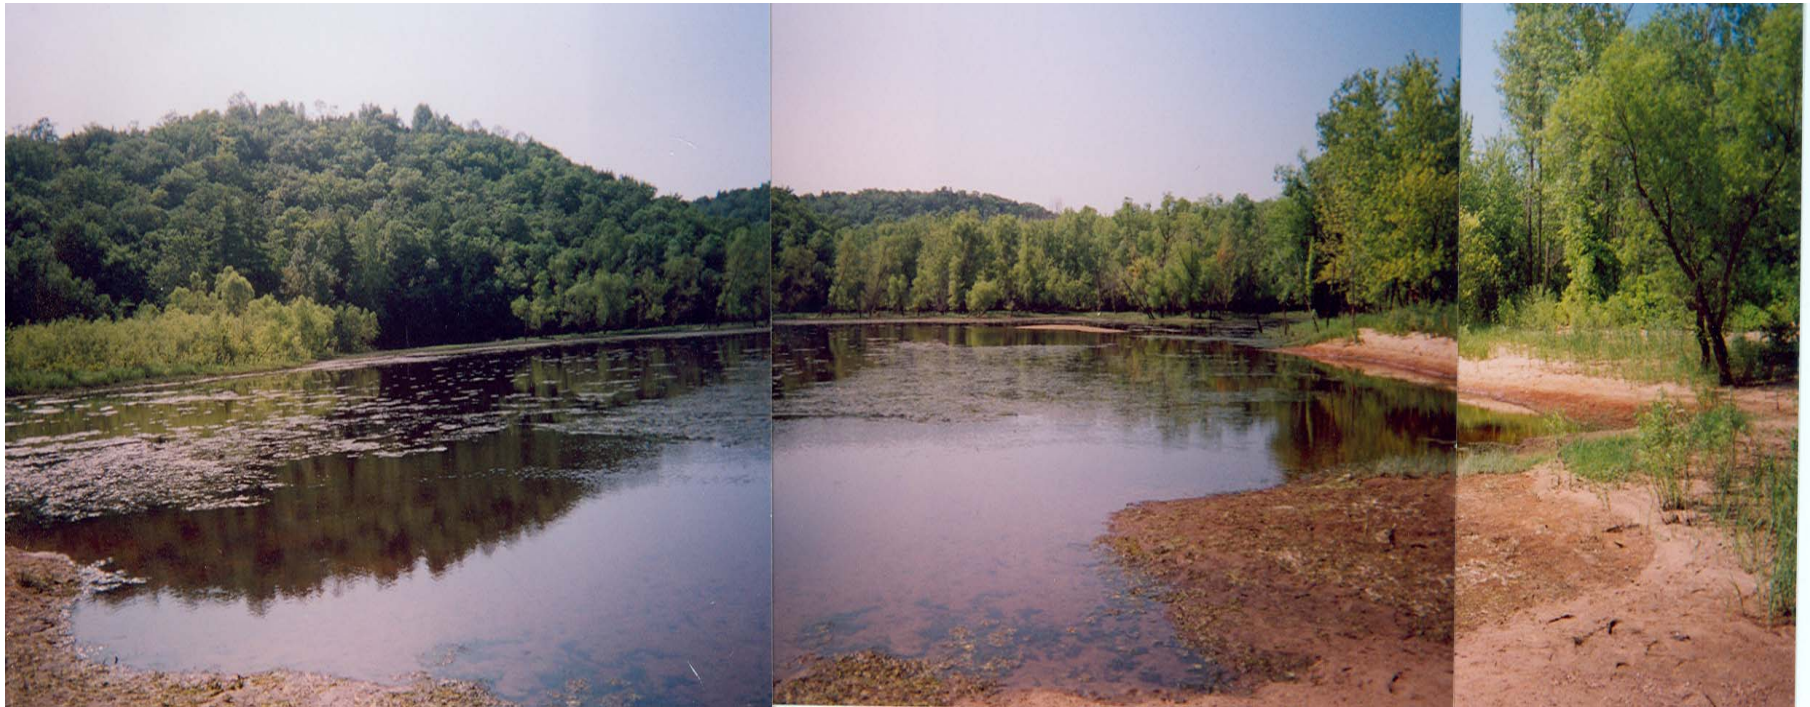
Kinnickinnic State Park

Transect 1 ---starting on beach on main channel of the river moving inland toward park picnic area

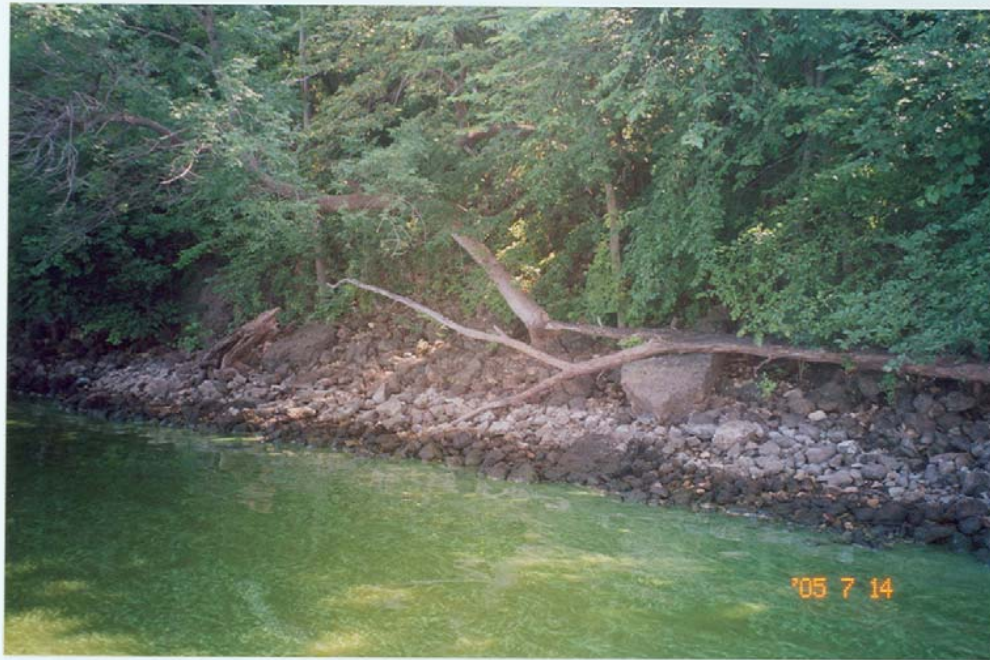
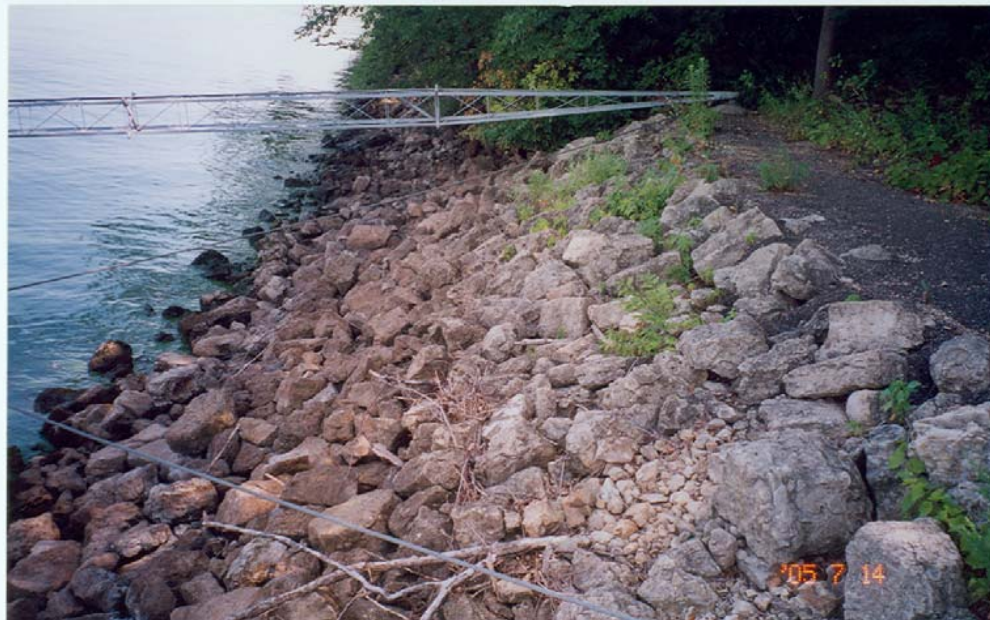
Transect 2—pier area

Notice water stain on
rocks in both photos
and the “browse line”
in the upper photo

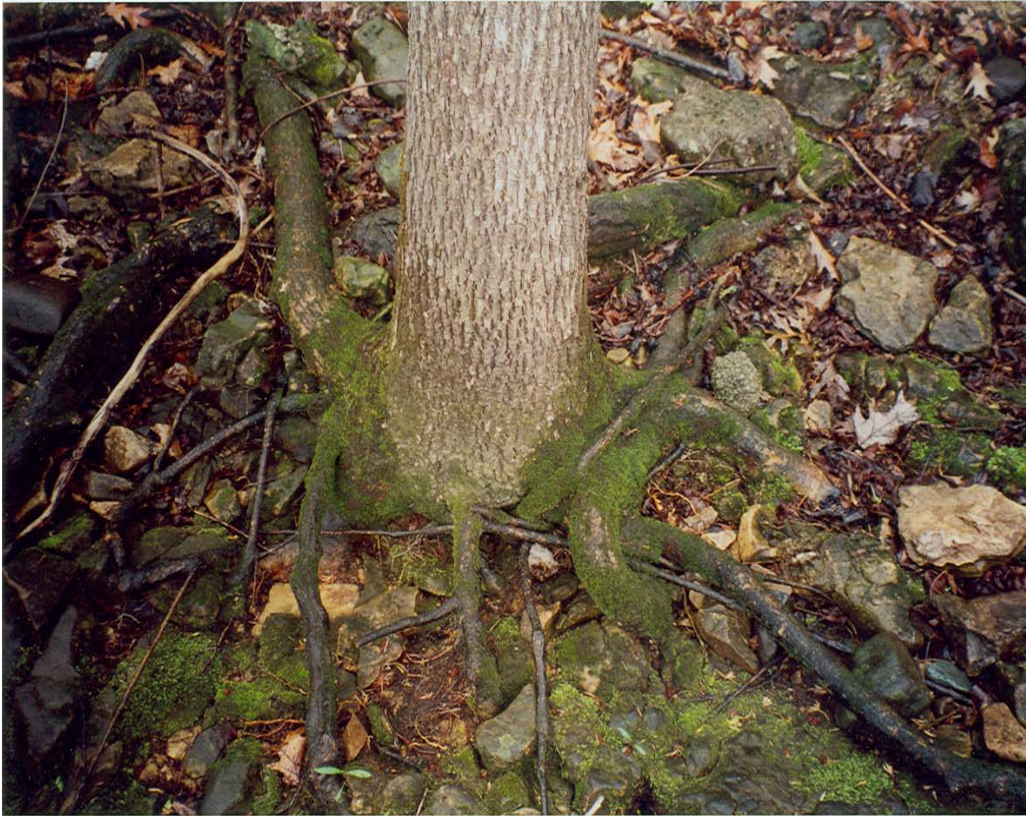
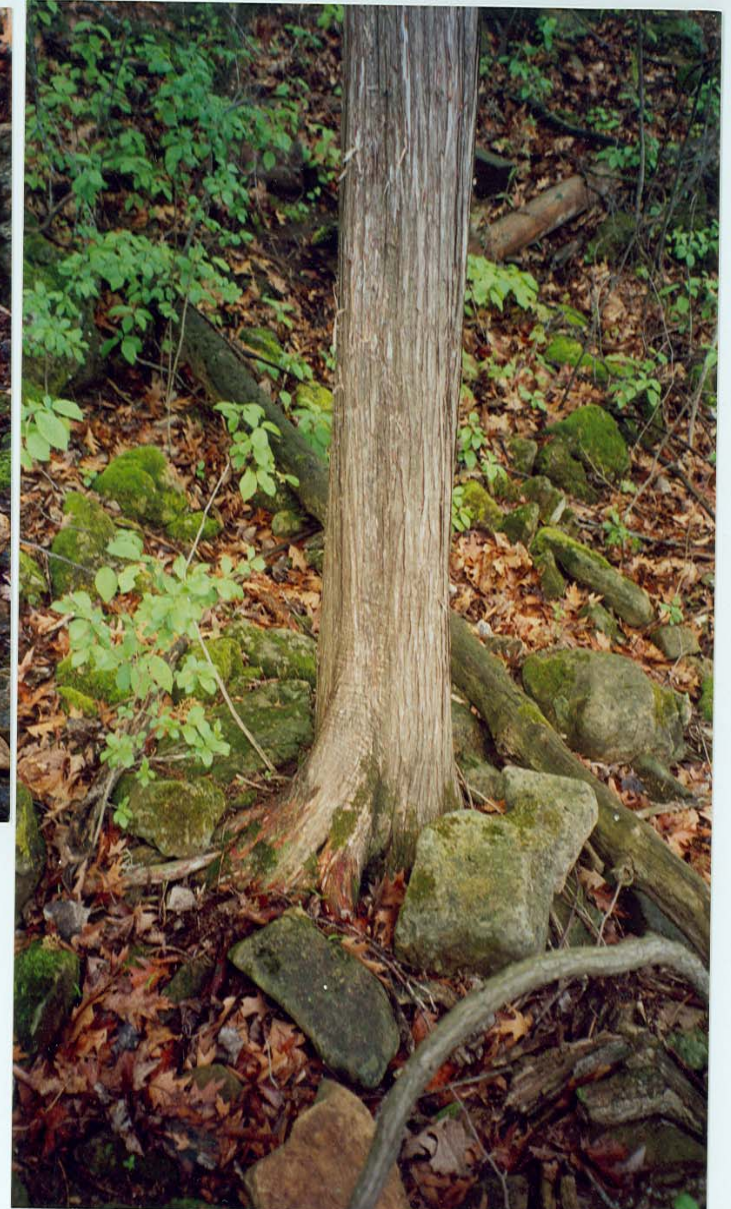
Photo taken at Bob Rolle's property—Transect 1

We documented presence of trees with exposed roots and trees without and their locations

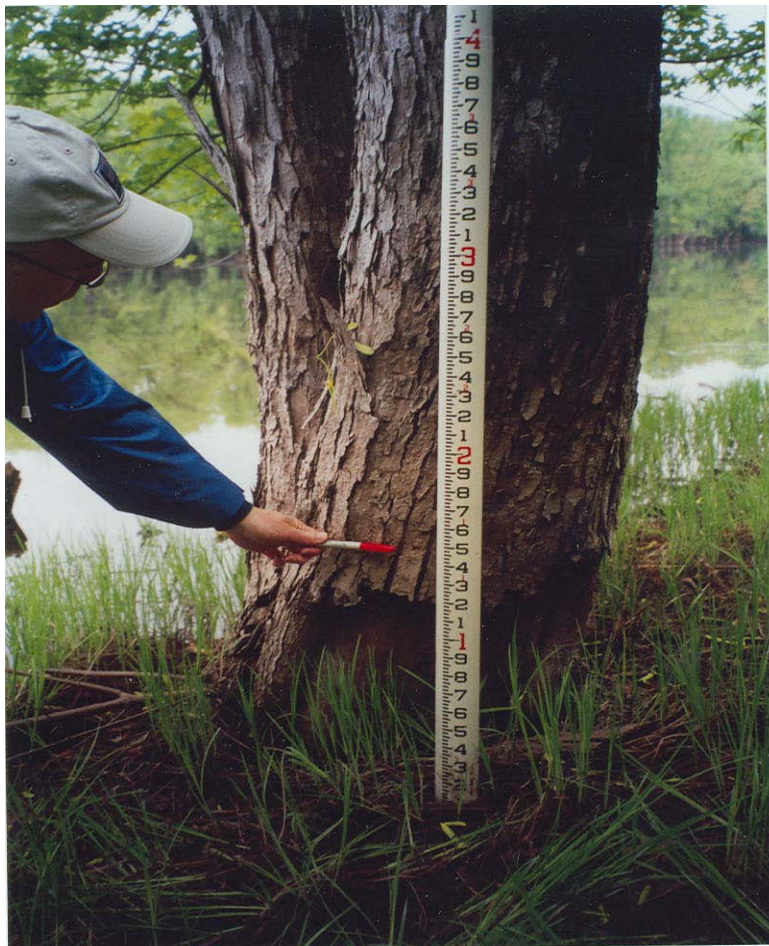
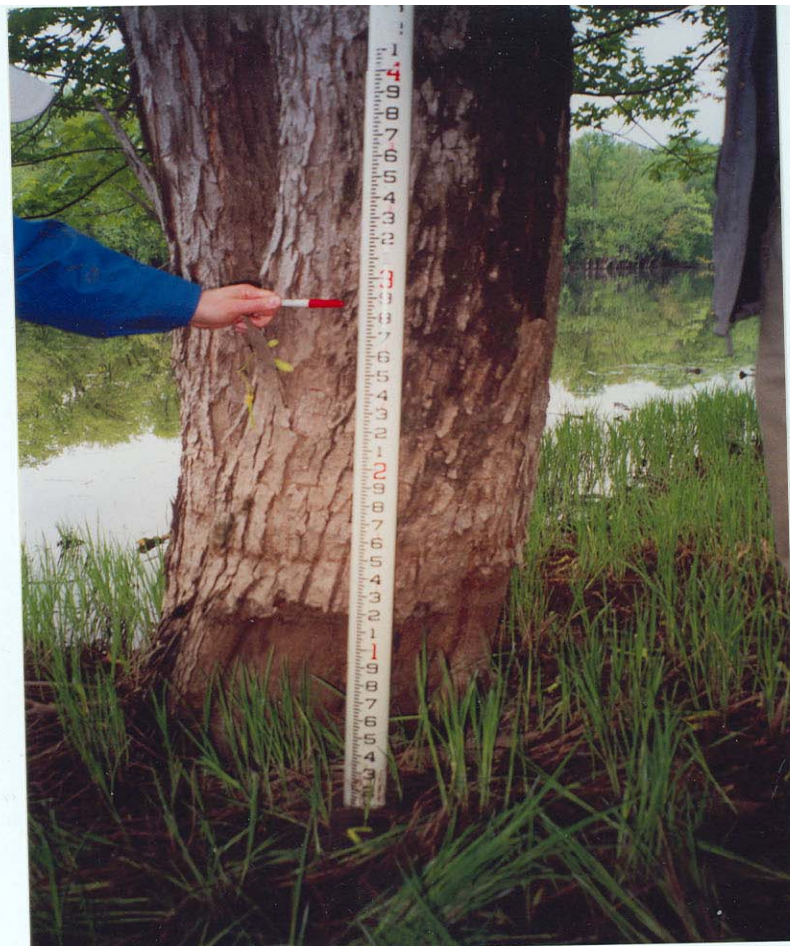
We documented water stains....Photo taken at Twin Springs Transect 1

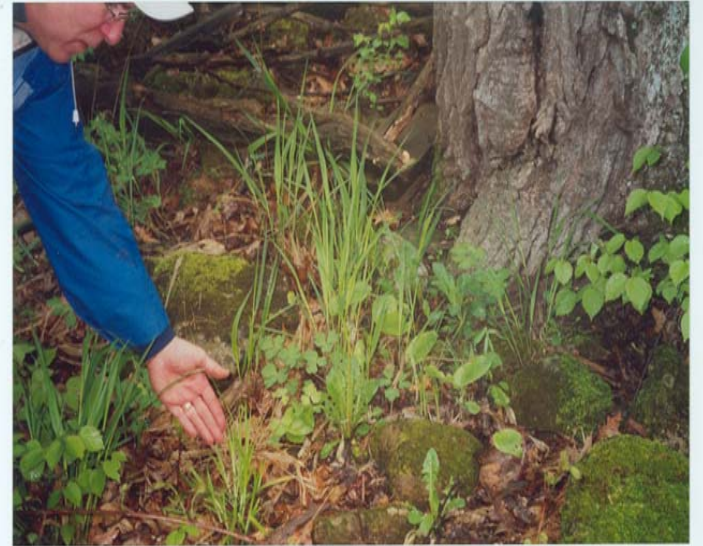
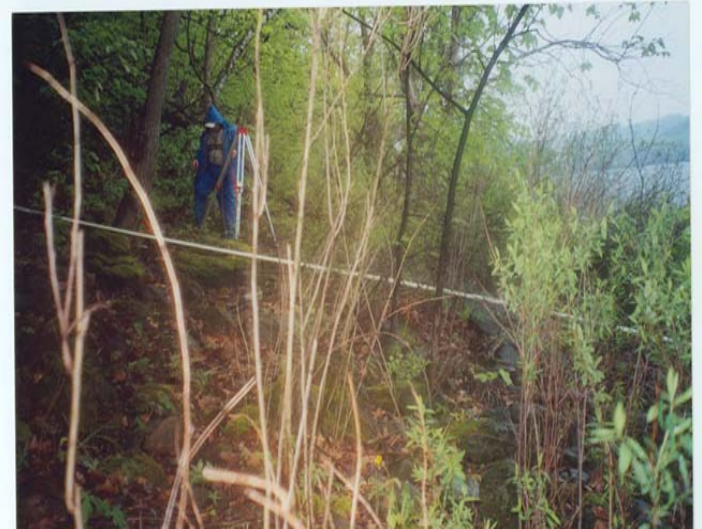
Photo taken at Bob Rolle's property—Transect 1

We inventoried vegetation and its location
